**EPA Request for Information
Magellan Pipeline Company, L.P.
Mile Post 110 #3-8" and #5-12" Pipeline Strikes
Nemaha County, Nebraska**

Re: Laser Induced Fluorescence Investigation
Magellan MP 110 Release, CR 724
Nemaha County, Nebraska
SP# 121011-SM-1229

U.S Department of Transportation Pipeline and Hazardous Materials Safety Administration	Report Date:		01/06/2012
	No.		20120009 - 16310 ----- (DOT Use Only)
ACCIDENT REPORT - HAZARDOUS LIQUID PIPELINE SYSTEMS			
A federal agency may not conduct or sponsor, and a person is not required to respond to, nor shall a person be subject to a penalty for failure to comply with a collection of information subject to the requirements of the Paperwork Reduction Act unless that collection of information displays a current valid OMB Control Number. The OMB Control Number for this information collection is 2137-0047. Public reporting for this collection of information is estimated to be approximately 10 hours per response (5 hours for a small release), including the time for reviewing instructions, gathering the data needed, and completing and reviewing the collection of information. All responses to this collection of information are mandator

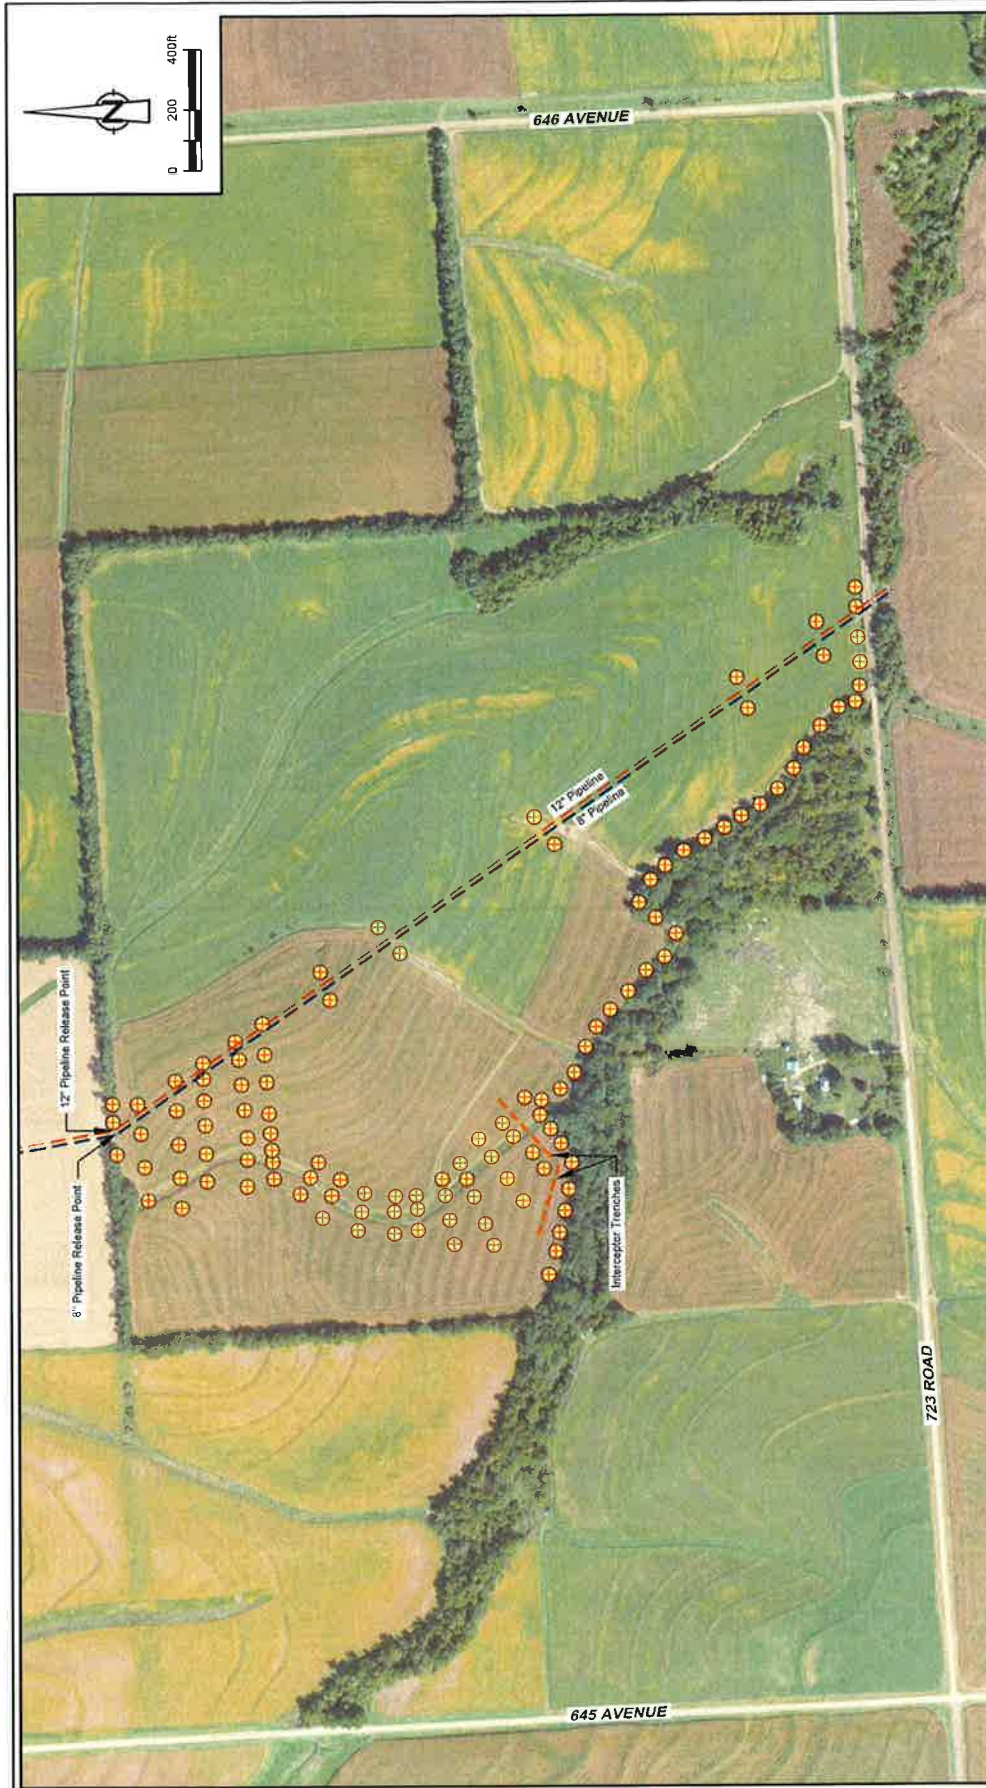
figure 3
 PROPOSED LIF LOCATION MAP
 MP 110 PIPELINE RELEASE
 SP#-121011-SM-1229
 NEMAHA, NEBRASKA
 Magellan Midstream Partners, L.P.

The areas proposed for the LIF investigation are shown on Figure 3. To evaluate the seeps along the unnamed tributary, the LIF investigation will start along the north side of unnamed tributary stream

bank in the agricultural field and proceed along the north side of CR 723. The LIF investigation will continue until the pipeline is crossed to evaluate if LNAPL is following any preferential pathway from the pipeline backfill. After this southern transect has been evaluated the LIF investigation will start at the release point of the pipeline and work in transects following encountered LNAPL down to the stream. The LIF locations will initially start on transects with LIF locations at intervals of 100-feet apart. Proposed locations may be moved, eliminated, or added based on the LIF results and restrictions of the Site. It is anticipated that the maximum depth of the LIF screening will be approximately 15 and 55 feet below ground surface (bgs) as identified in the Site boring logs. These depths may be adjusted based on the field observations during the LIF investigation.
